MFJ DRY DUMMY LOAD MODEL MFJ-260

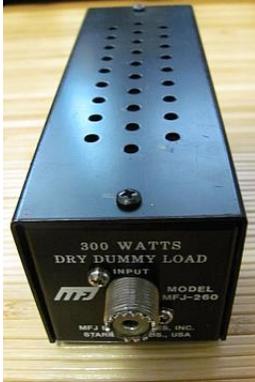
It looked in good shape but I checked the load resistor to see how close it was to 50 Ω . The measurement was taken at the SO-239 connector and it measured about 64 Ω .

Your first thought would be that the load was overheated. The load is rated for intermittent operation up to 300 Watts and up to 160 MHz. The power rating of the resistor used as the load looks like at about 50 Watts but not sure about this. I remembered he was a QRP guy and it probably did not see any more than a few Watts at one given time. Checking the internal resistor directly showed about 51 Ω .

The problem was painted rivets used to connect the SO-239 to the box and internal overspray. To fix the problem I drilled out the rivets and removed the internal paint around the SO-239 area and other areas where a ground was required using a Dremel tool. The rivets were replaced with #6 machine screws, nuts and lock washers. After re-assembly the resistance measured at the SO-239 connector was about 51 Ω .

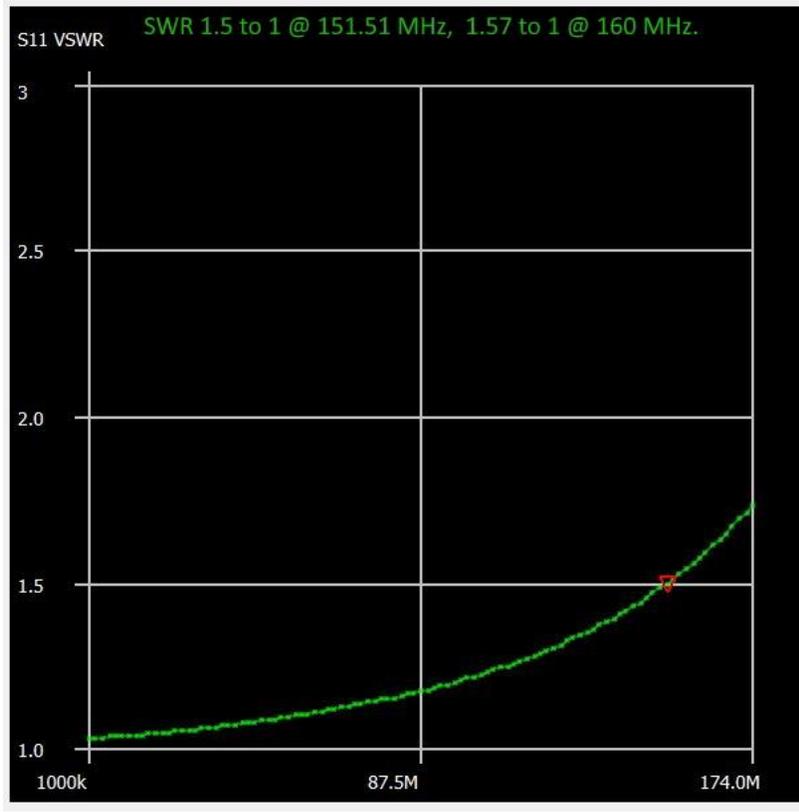
Here is an SWR plot of this dummy load using a Hugen NanoVNA-H4.

The red marker at the 1.5 to 1 SWR line is at 151.51 MHz.

MFJ rates this dummy load to 160 MHz. I presume this is at 1.5 to 1 SWR. This dummy load didn't not quite make it but close according to the plot.
